ADDENDUM NO. 1

PROJECT: Makoshika State Park Switchback Road Repair

Final Geotechnical Engineering Report

Makoshika State Park Road Stabilization

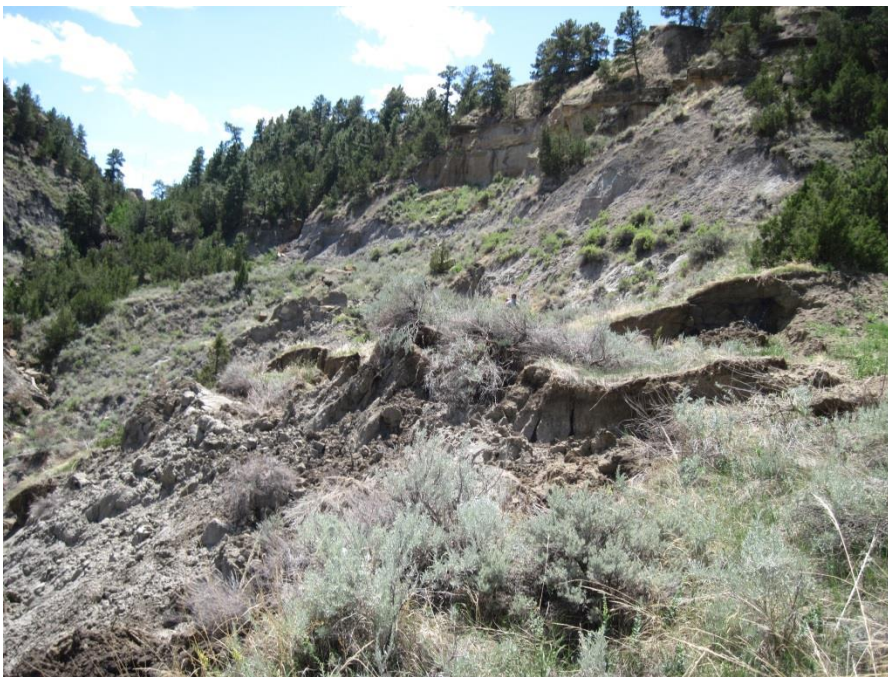
The 2011 slide appears to involve primarily silty/clayey sand colluvium (derived from the weathering of adjacent sandstone slopes) that is moving at the sand-shale interface; movement did not appear to have extended significantly into the underlying shale. This conclusion has been based on observations made during the 2012 field work which found the sandy terrain higher on this slope segment to be extremely broken and irregular as compared to uniform

slope conditions noted lower in the shale portion of the slope. The trigger for this sliding is believed to be elevated groundwater due to infiltration associated with heavy spring rains in 2011. This resulted in destabilizing seepage forces exiting the slope face above the shale and uplift on the slide mass reducing resistance along the sand-shale interface. The slide conditions are shown in the following photographs:

2011 slide in sand soils in the upper reaches of the slope near Station 16+00

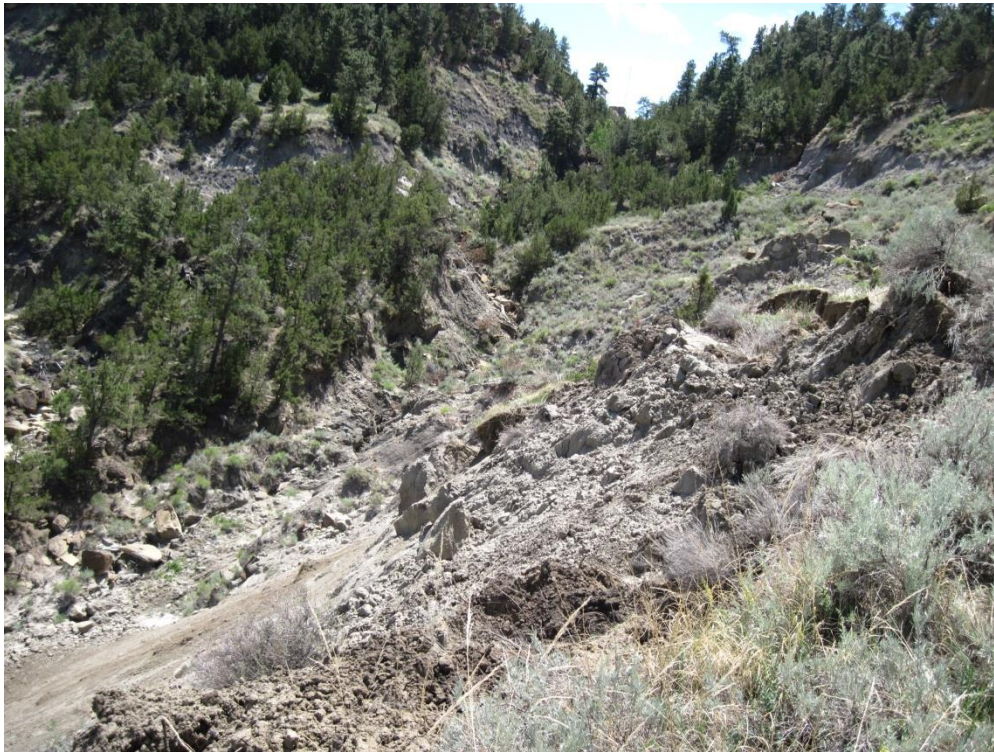
Exit of the 2011 slide at the shale interface above the coulee

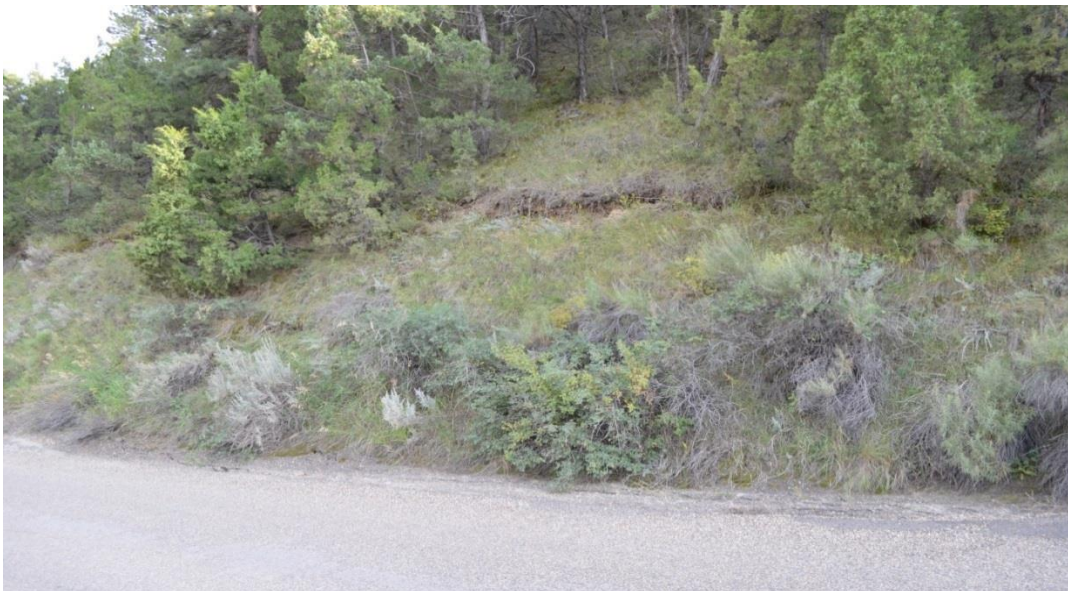
Small scarp above the roadway along the switchback in vicinity of Station 14+00

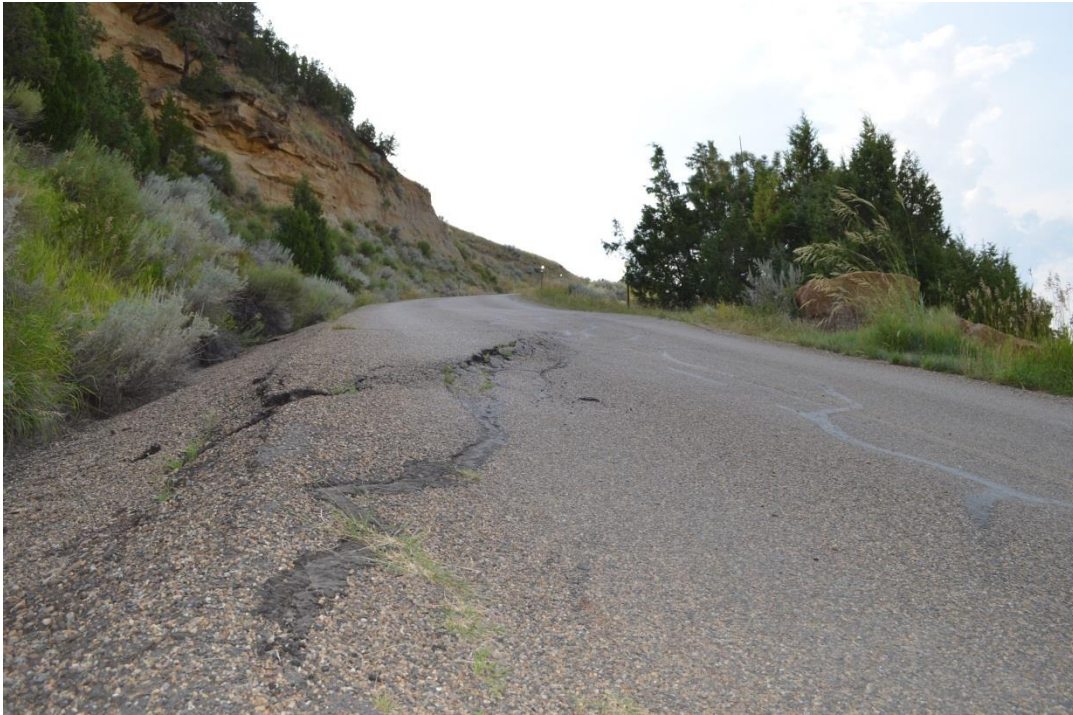
Cracking and differential movement in pavement in vicinity of Station 14+00

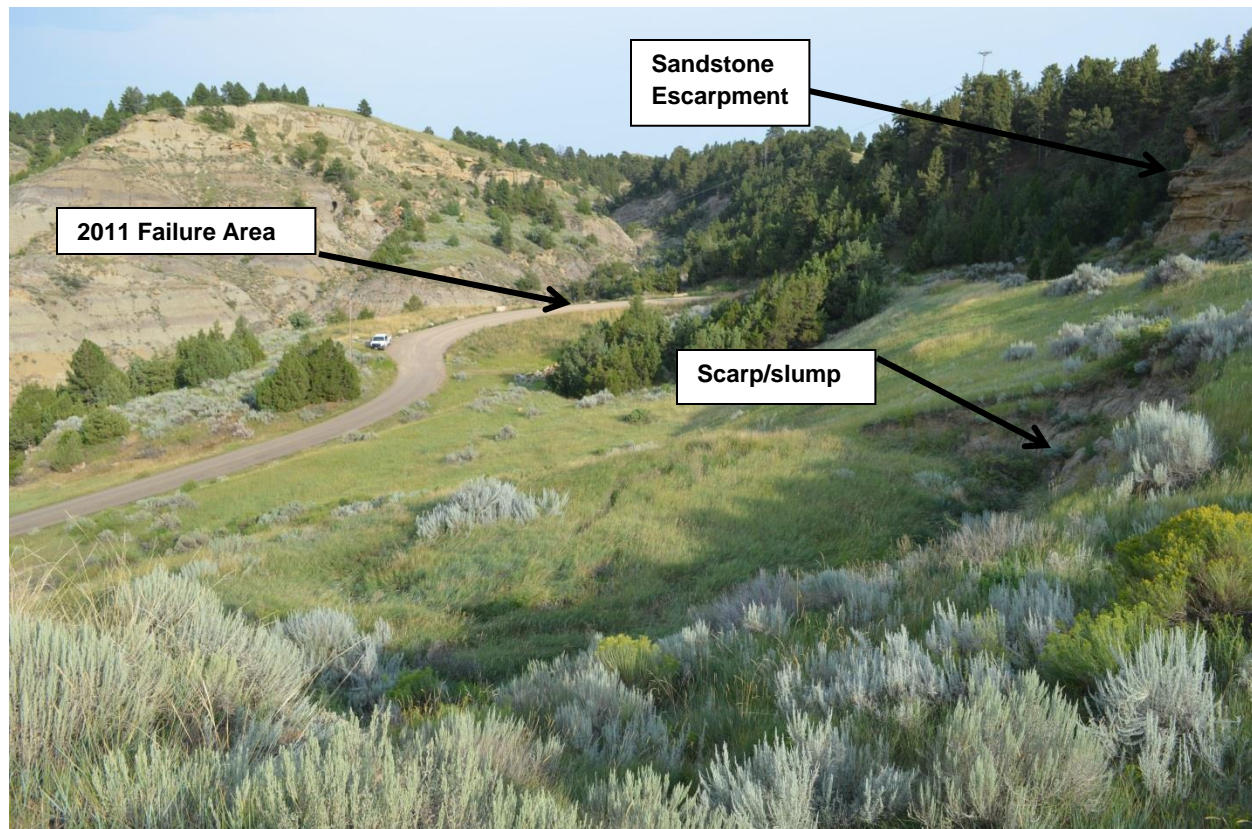
Scarp and bulge zone from recently active slump moving east inside the switchback

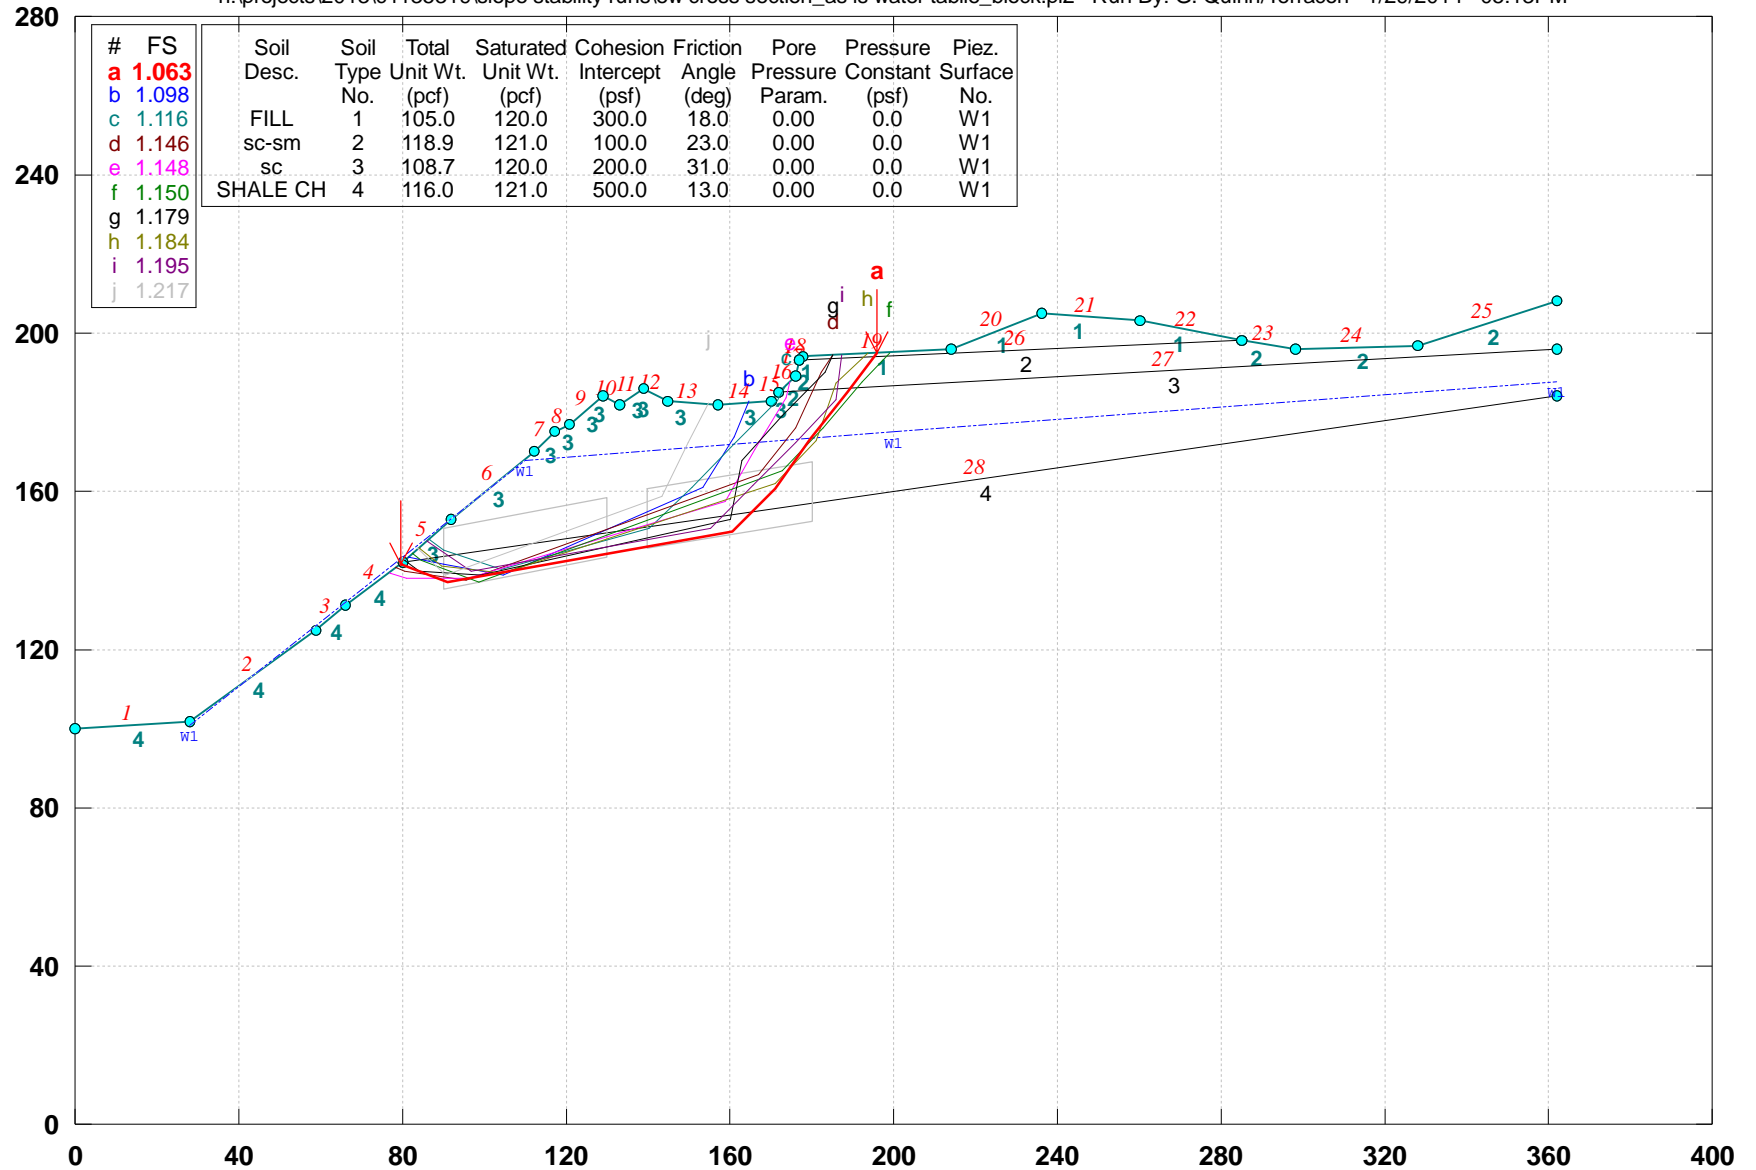
Makoshika 2011 Slide Existing Condition/Block Failure EXHIBIT D-1

The analysis was initiated with backcalculation for the existing failed slope to ascertain that a reasonable groundwater level together with the shear strength parameters determined by laboratory testing that would yield a Factor of Safety at approximately $FS = 1$, which represents the current marginal stability condition. This check was conducted for both circular and block sliding surfaces initiating within the observed failure zone along the slope crest and exiting on the slope along or above the shale interface. This analysis was based on an idealized subsurface cross-section through Borings DH-4 and DH-5.

The shear strength along the shale surface was reduced to a magnitude between peak and residual conditions to reflect the likelihood that prior shearing had occurred in this zone and caused some strength loss. The Factors of Safety for the existing slope were determined to be on the order of $FS = 1.06$ and $FS = 0.92$ for sliding block and circular failure surfaces respectively as shown on Exhibits D-1 and D-2 in Appendix D. The groundwater level in these analyses was taken to be within ± 15 feet of prevailing ground surface as was measured during the fall 2013 monitoring trip. Although this groundwater level is probably low relative to the 2011 failure condition, the analyses results were considered to reasonably validate the model, and remedial analyses were then conducted.

GSTABL7 v.2 FSmin=1.063

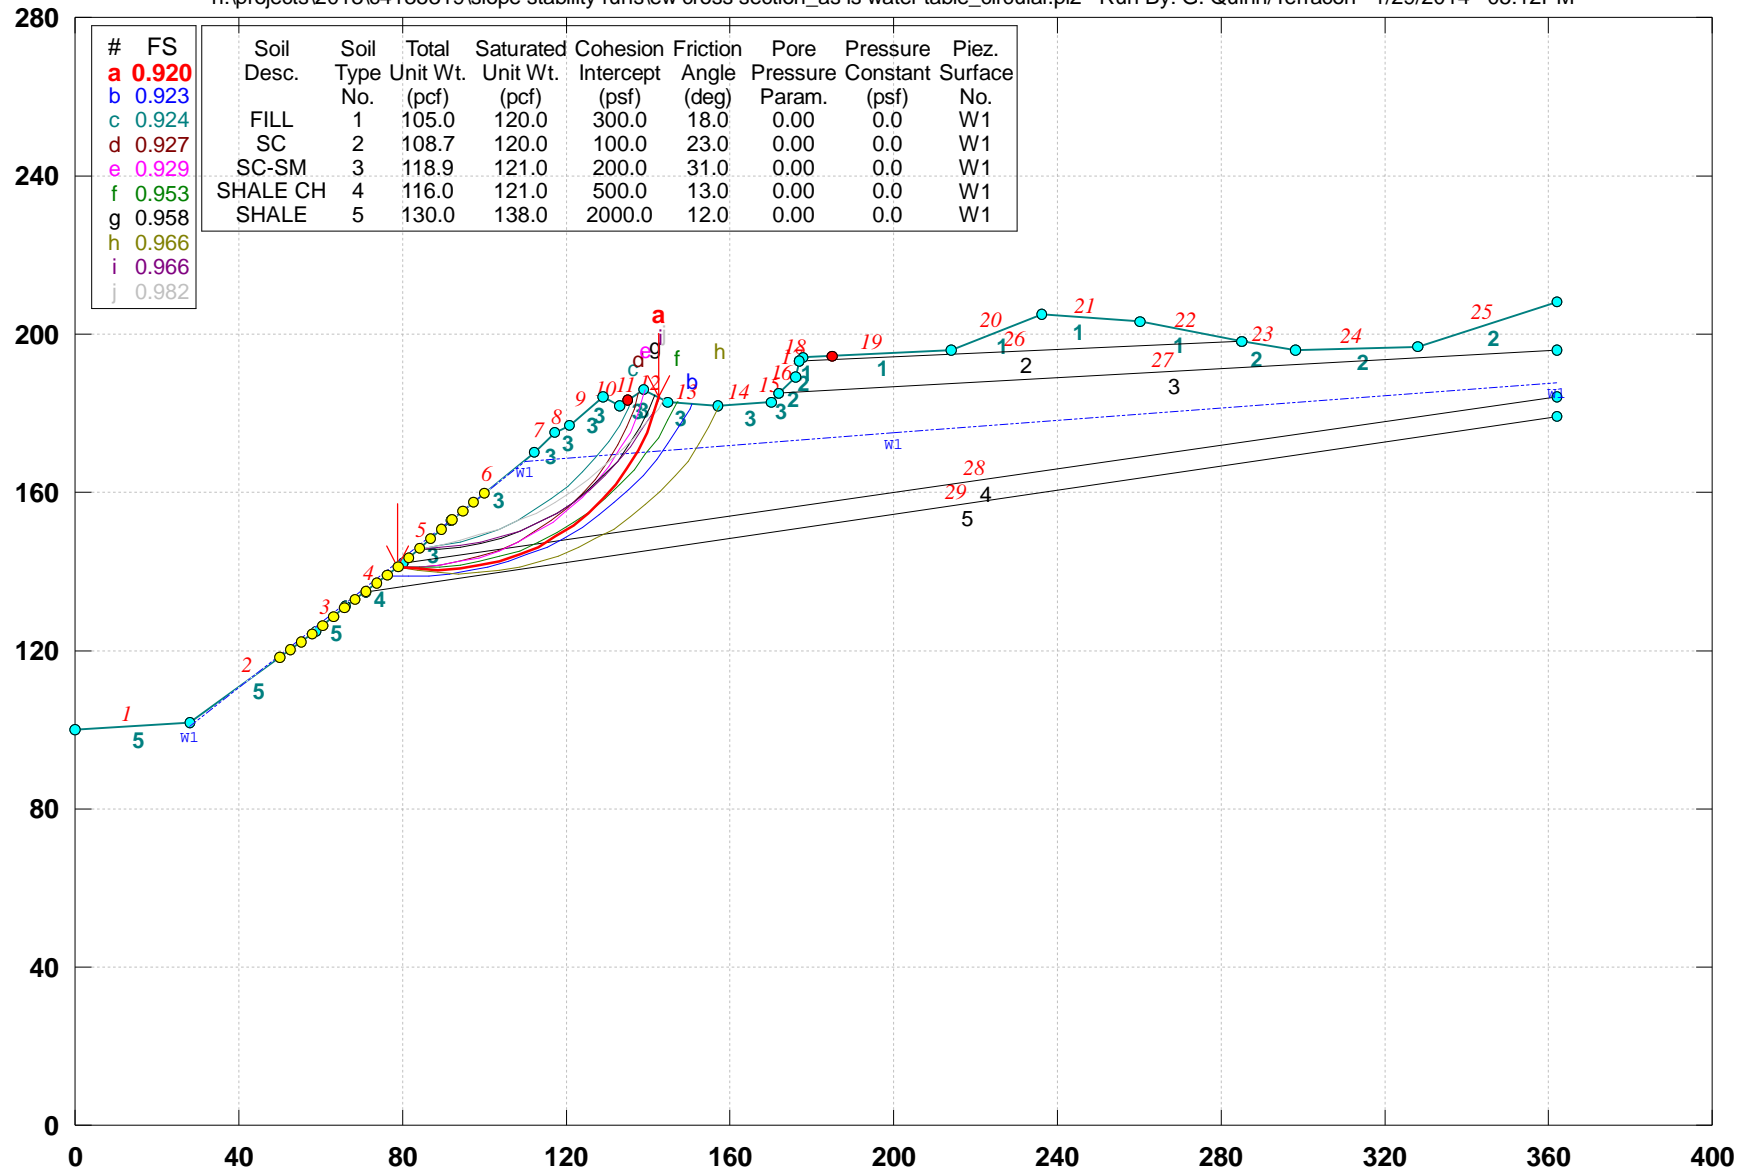
Makoshika 2011 Slide Existing/ Circular Failure EXHIBIT D-2

GSTABL7 v.2 FSmin=0.920

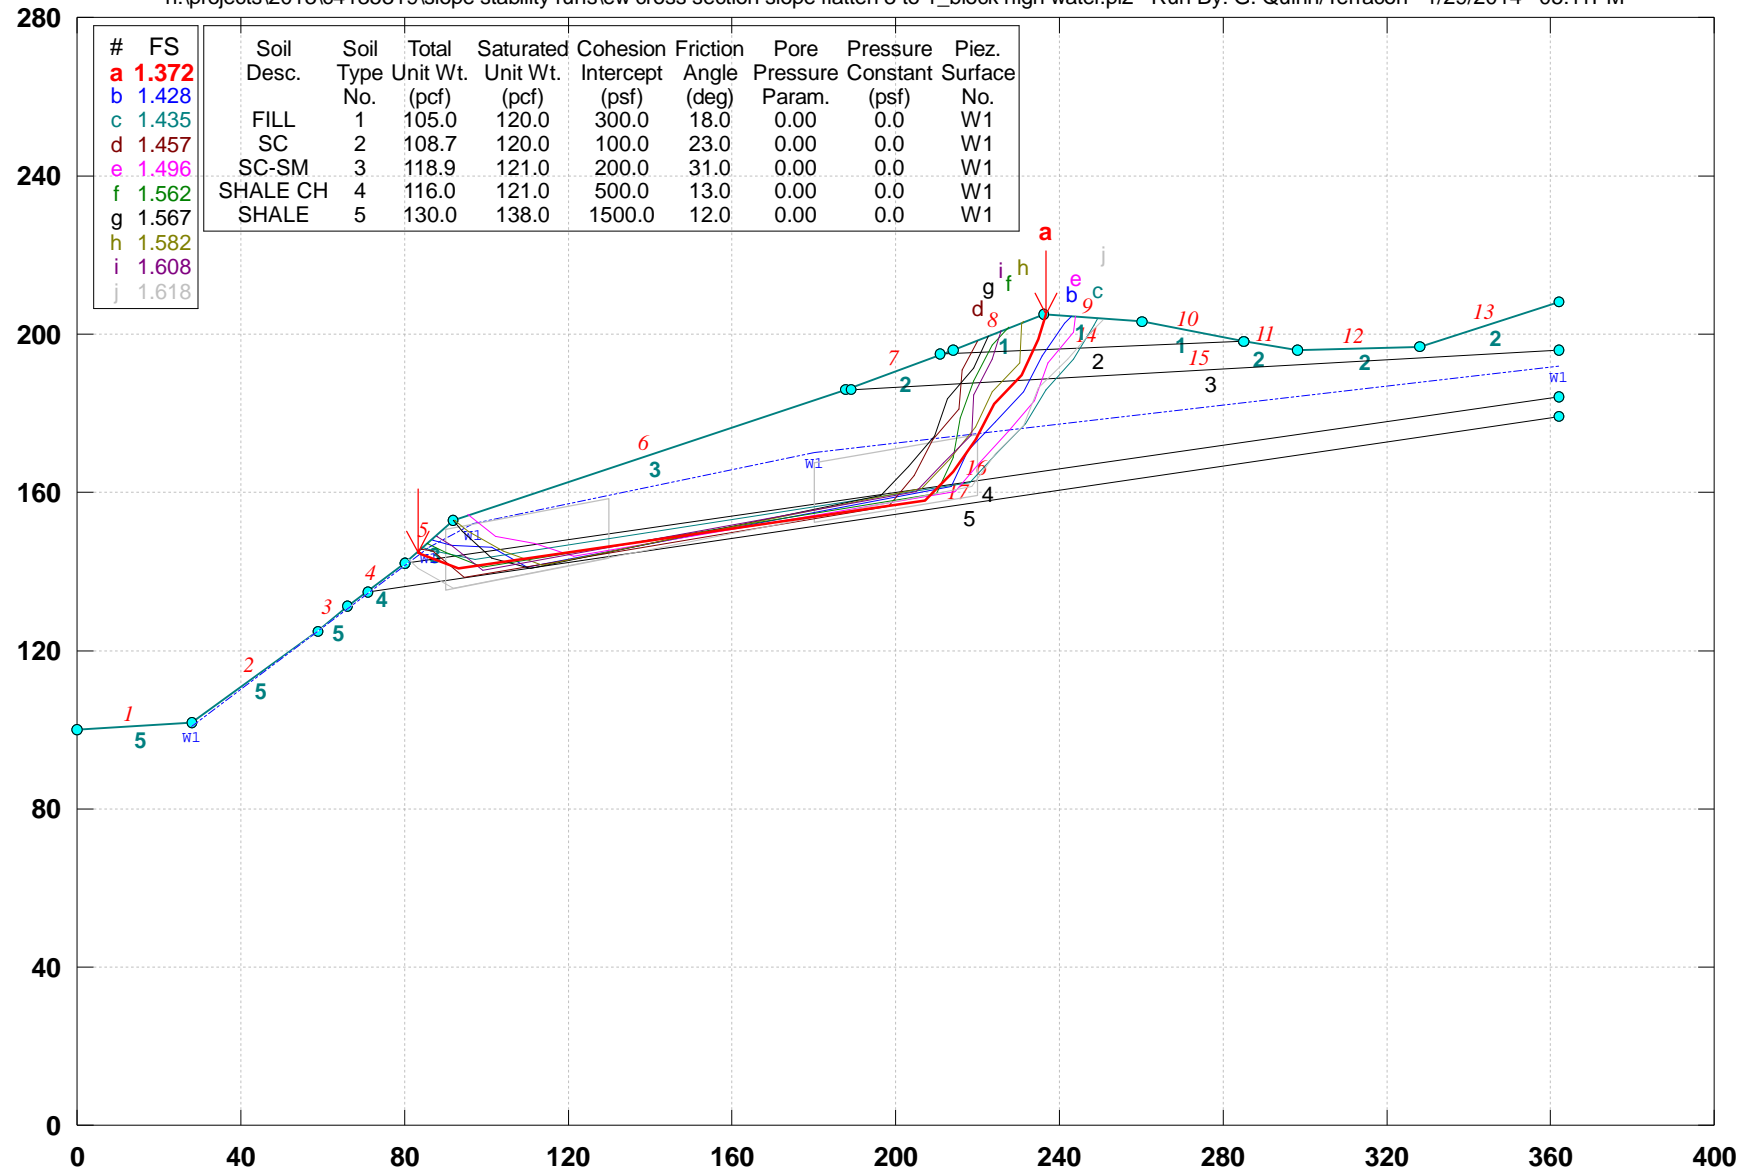
Makoshika 2011 Slide Repair/Block 3:1 w/ Drains EXHIBIT D-3

Stability analyses were conducted with the slope flattening and horizontal drains for both sliding block and circular failure modes. Factors of safety of $FS = 1.37$ and $FS = 1.52$ were determined for the block and circular failure surfaces respectively; these results are shown on Exhibits D-3 and D-4 which represent the concluding analyses for numerous failure scenarios. The block factor of safety is lower due to the longer failure surface generated at the shale interface where shear strength intermediate between peak and residual was input for conservatism.

GSTABL7 v.2 FSmin=1.372

The remedial concept was based on maintaining the 2012 inboard roadway alignment shift as a buffer zone separation from the 2011 failure limits to the extent possible. This would allow flattening the upper sandy portion of the slope as a prudent next step since the existing inclination of $\pm 40^\circ$ was clearly not sustainable in the loose sand. Since seepage is believed to be a major contributing factor to the instability at this location, as well as in the surrounding area of the hillside, internal drainage is recommended as a critical component of the remediation program.

In addition, the installation of horizontal drains is recommended as a primary means to lower the groundwater level in the failure area and upslope from the infield where past slope movements are apparent. Horizontal drains are a conventional means of lowering groundwater to improve stability, and such drains are generally well-suited for sand slopes. The spatial arrangement of the drains is typically an experienced-based, empirical process and production of the drains is usually variable making the design inexact with field modifications often necessary. For purposes of analysis, it has been assumed that two tiers of drains installed in a fan pattern to cover the slope and the switchback infield will be required to reduce water levels to approximately one half of the sand thickness on the interior of the slope with progressive drawdown toward collection points at the slope face.

The tiered drains are recommended to fan from entry levels on the slope face at approximate Elevations 2345 and 2360 between projected Stations 16+25 and 16+50. The fan sweep has been set to subtend angles of 20° and 35° for the lower and upper tiers respectively. Four drain lines are recommended for the lower tier and five lines on the upper. Extension of the drains deeply upslope into the infield area to the west is believed to be beneficial for improving overall hillside stability by lowering groundwater levels. Drains of 450 to 500 feet in length at an installation angle of $\pm 7^\circ$ above horizontal are proposed for the lower tier, while much shorter drain lines on the order of 150 to 225 feet are proposed at similar inclination for the upper tier.

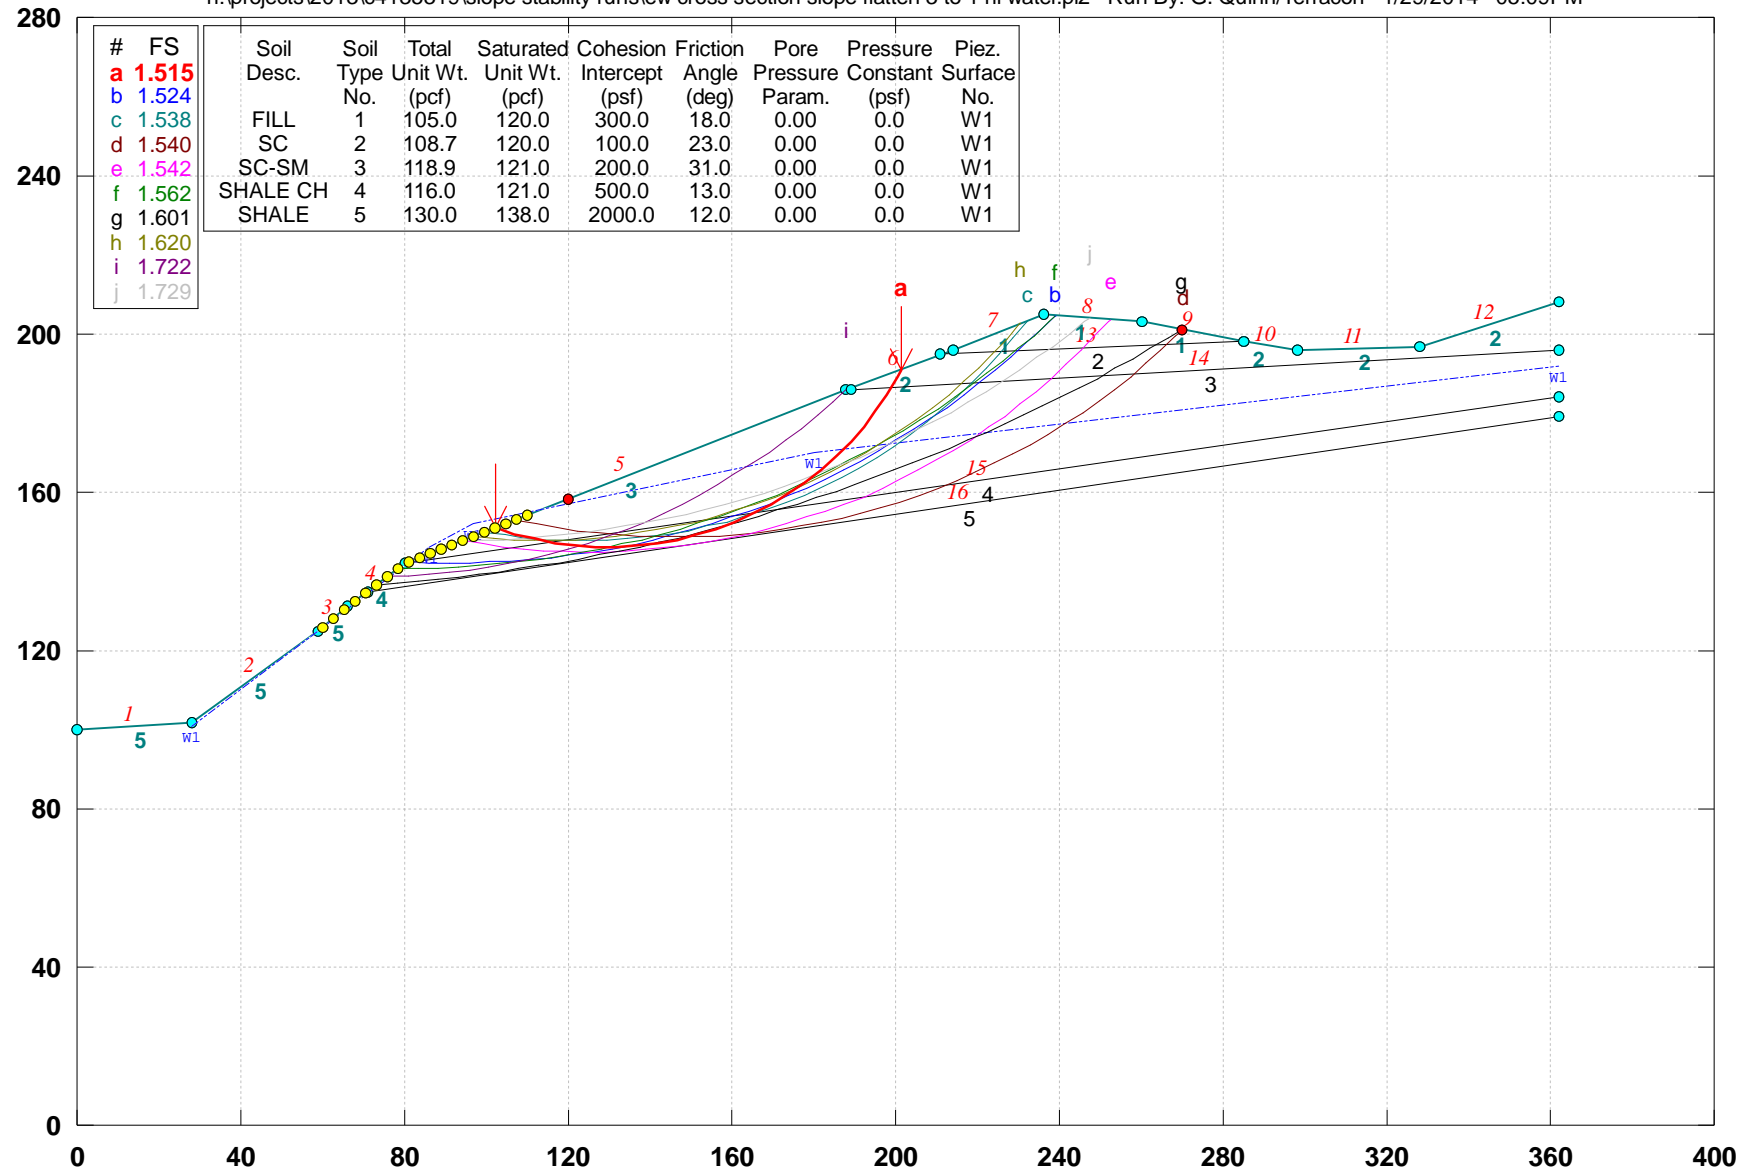
Makoshika 2011 Slide Repair/Circular 3:1 w/ Drains EXHIBIT D-4

GSTABL7 v.2 FSmin=1.515

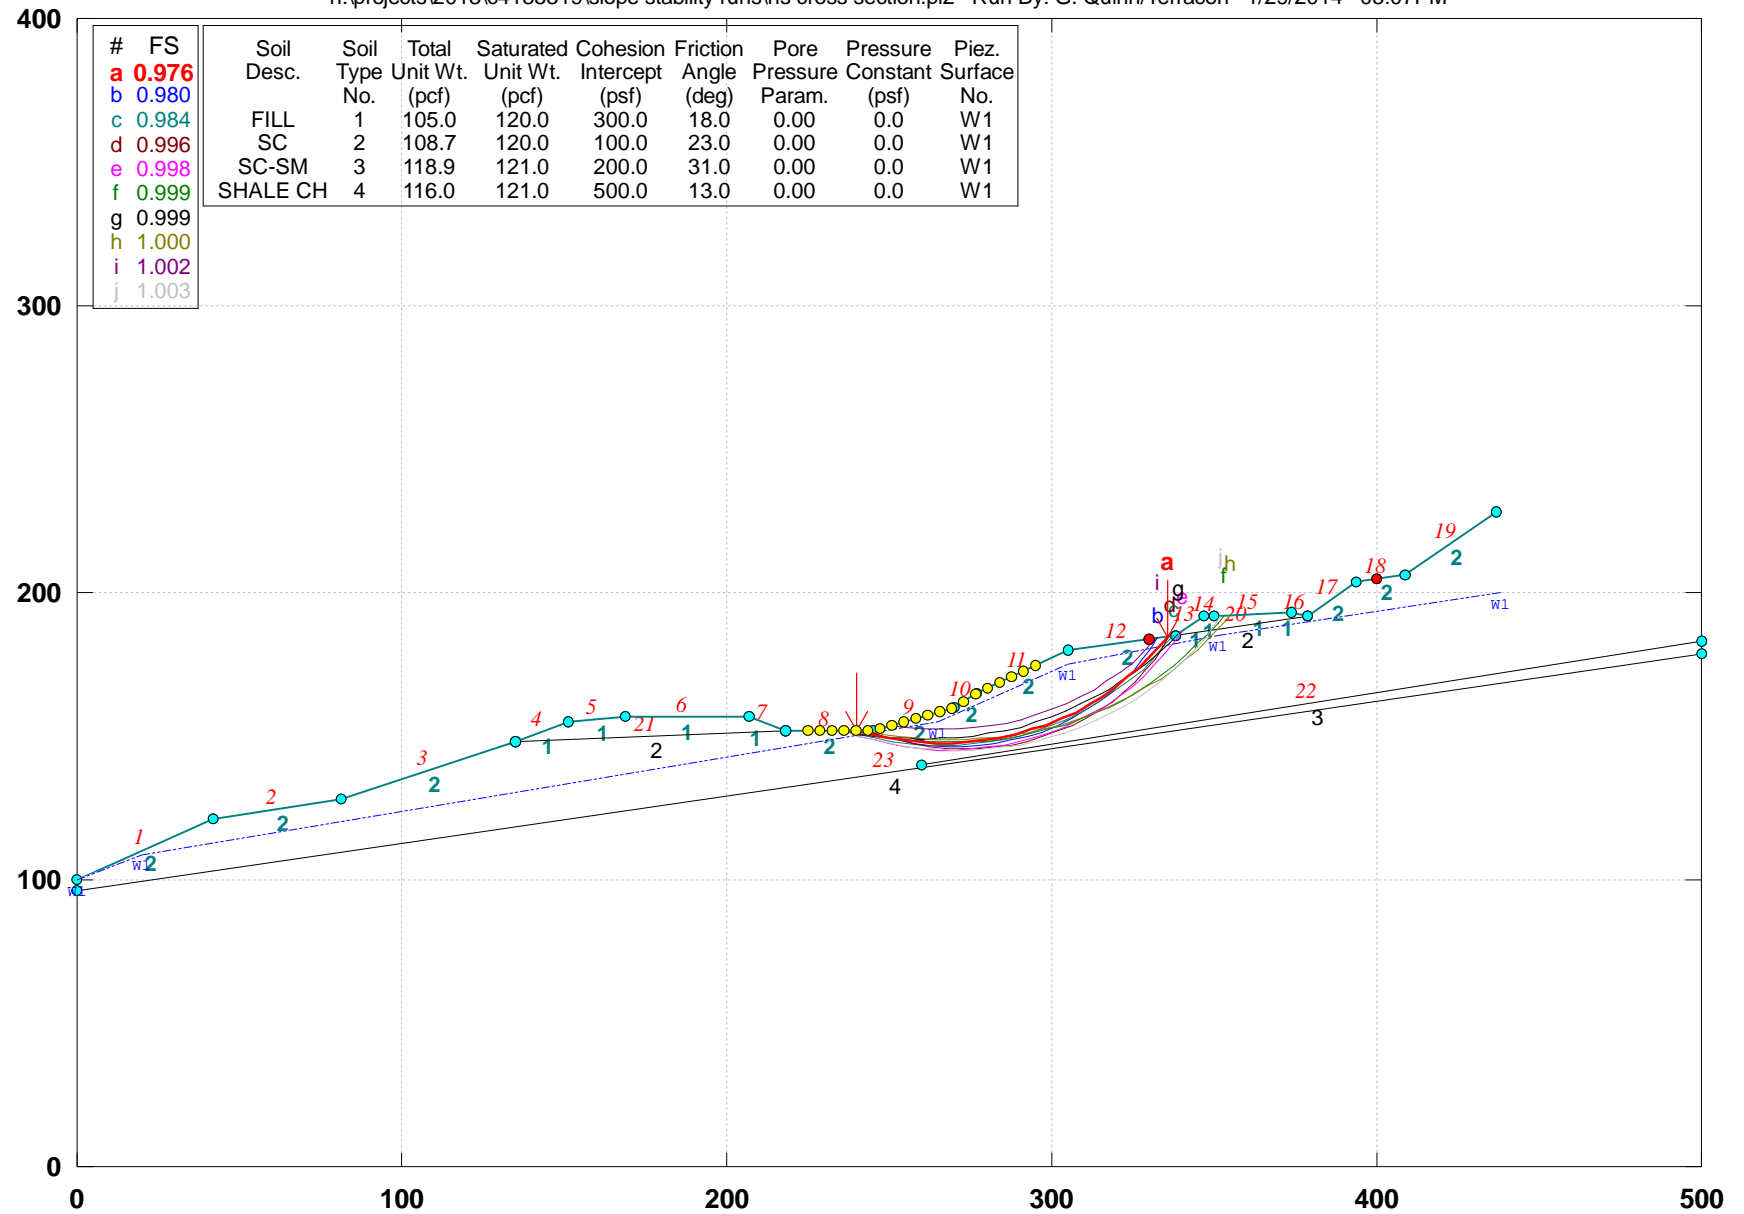
Makoshika Sta 12+00-15+00 Slide Existing Condition/Circular EXHIBIT D-5

Initial backculatation of existing stability conditions for this slide area was conducted as described above for the 2011 slide using a subsurface cross-section through DH-4 and DH-6. Numerous circular and sliding block failure surfaces with groundwater near the slope surface were considered using the same shear strength parameters as for the 2011 analysis. The results of these analyses found factors or safety at $FS = 0.98$ and $FS = 1.04$ for circular and sliding block failure surfaces respectively, as shown on Exhibits D-5 and D-6. This outcome indicated the model to be reasonable in producing failure scarps and slump features as observed in the geologic reconnaissance.

GSTABL7 v.2 FSmin=0.976

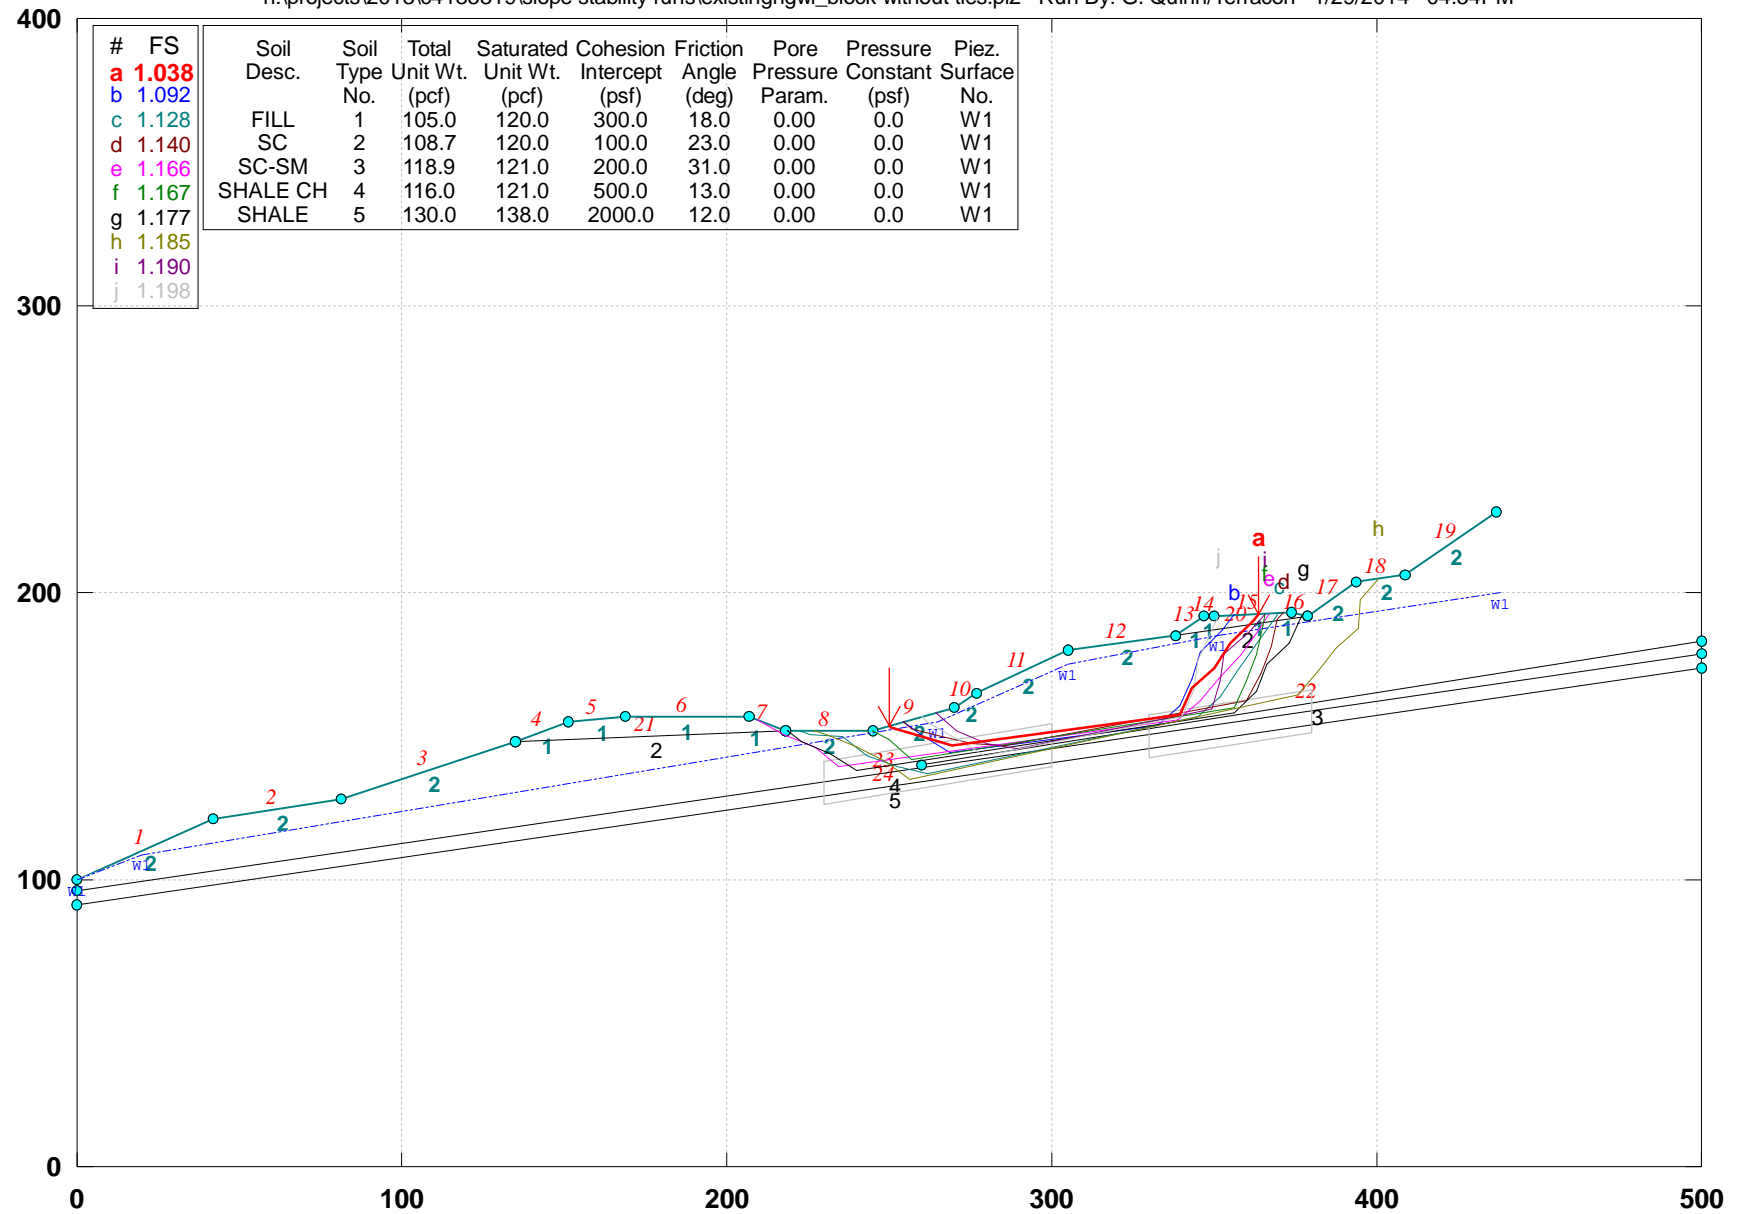
Makoshika Sta 12+00-15+00 Slide Existing Condition/Block EXHIBIT D-6

GSTABL7 v.2 FSmin=1.038

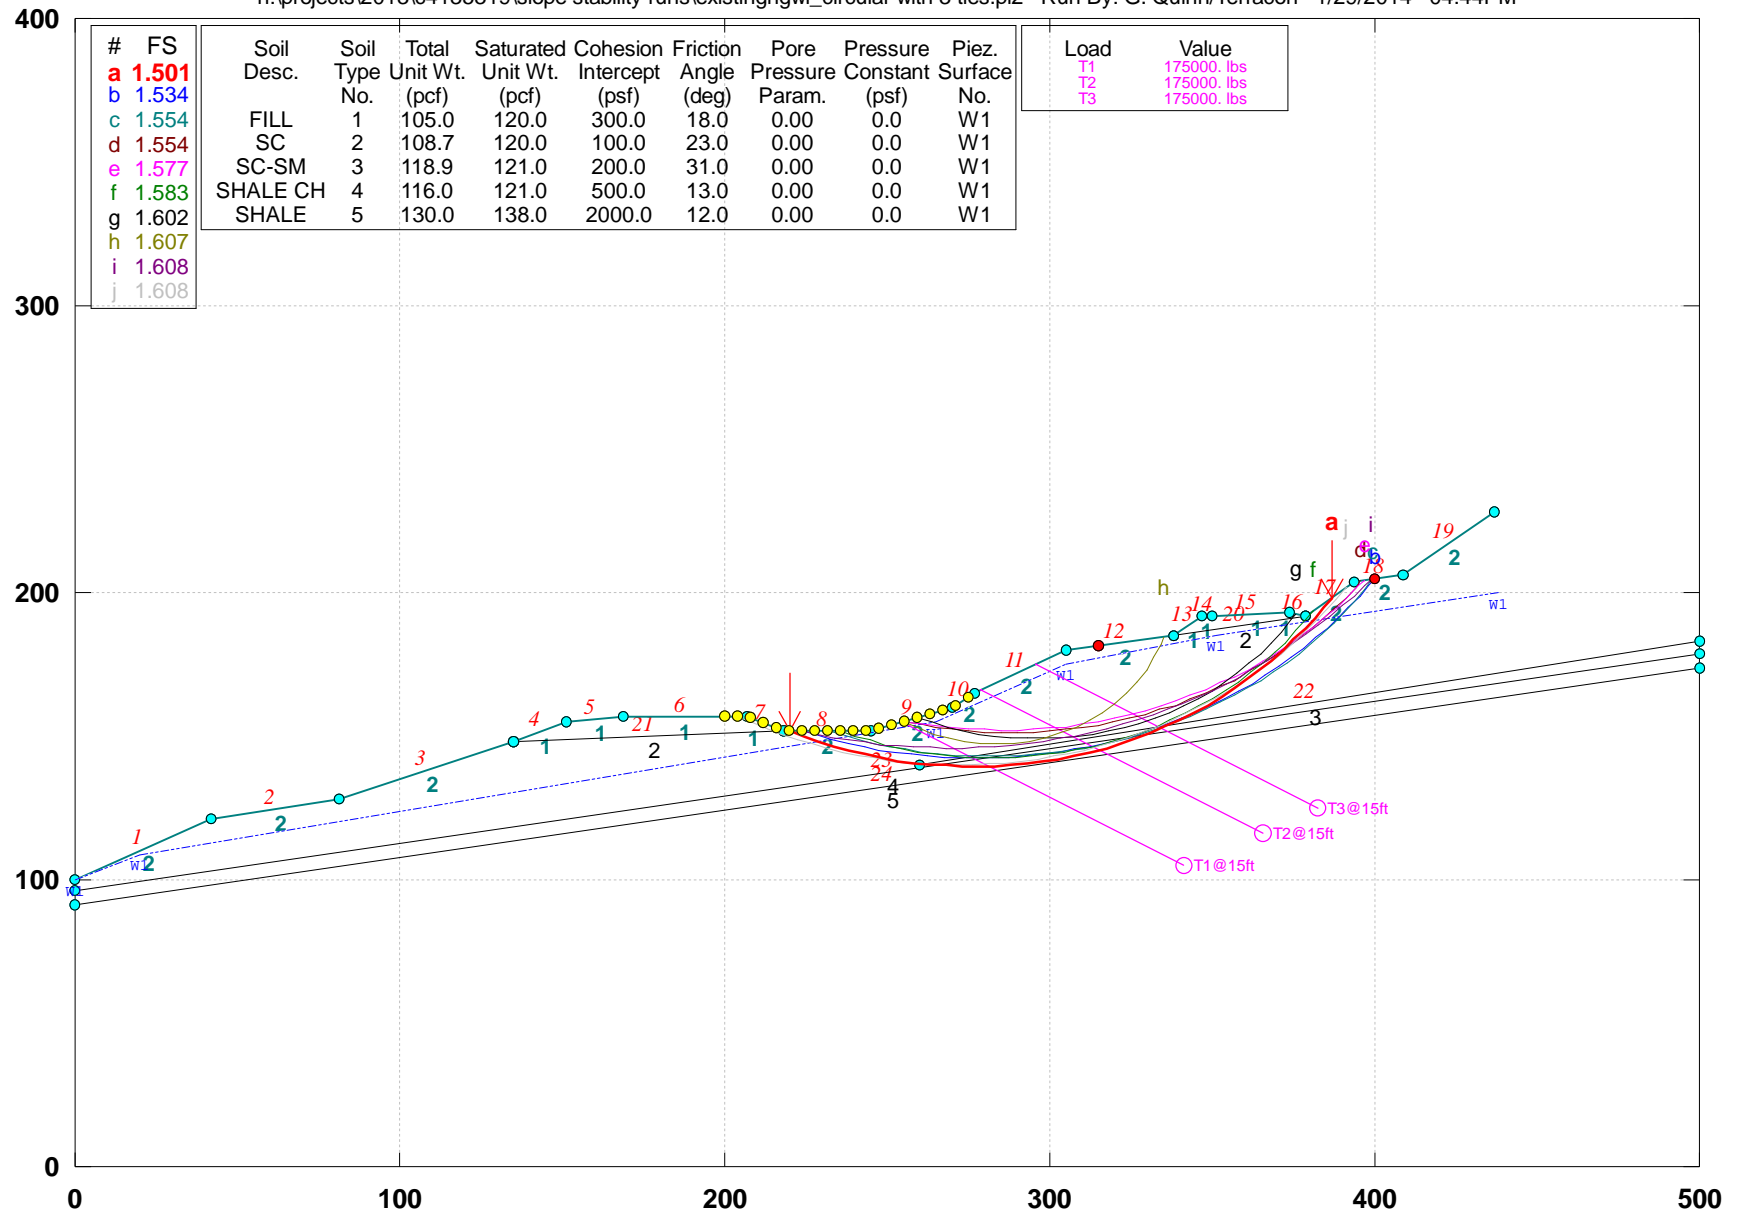
Makoshika Sta 12+00-15+00 Slide Repair/ Circular EXHIBIT D-7

The remedial analyses were conducted based on three rows of anchors tensioned to a working capacity of 175,000 pounds each; anchor spacing within each row was set at 15 feet. Based on the anchor contribution exclusive of any underdrainage effects, the factors of safety were then found to increase to $FS = 1.50$ and $FS = 1.62$ for circular and sliding block surfaces respectively. These results are as shown on Exhibits D-7 and D-8 which again present results culminating a series of numerous stability runs.

GSTABL7 v.2 FSmin=1.501

of the primary north-trending slide movement. Post-tensioned, multi-strand anchors are recommended for this application. It is further recommended that infiltration near the head of this slide be intercepted and the seepage line lowered as possible via the installation of underdrainage in conjunction with lining of the inboard ditch.

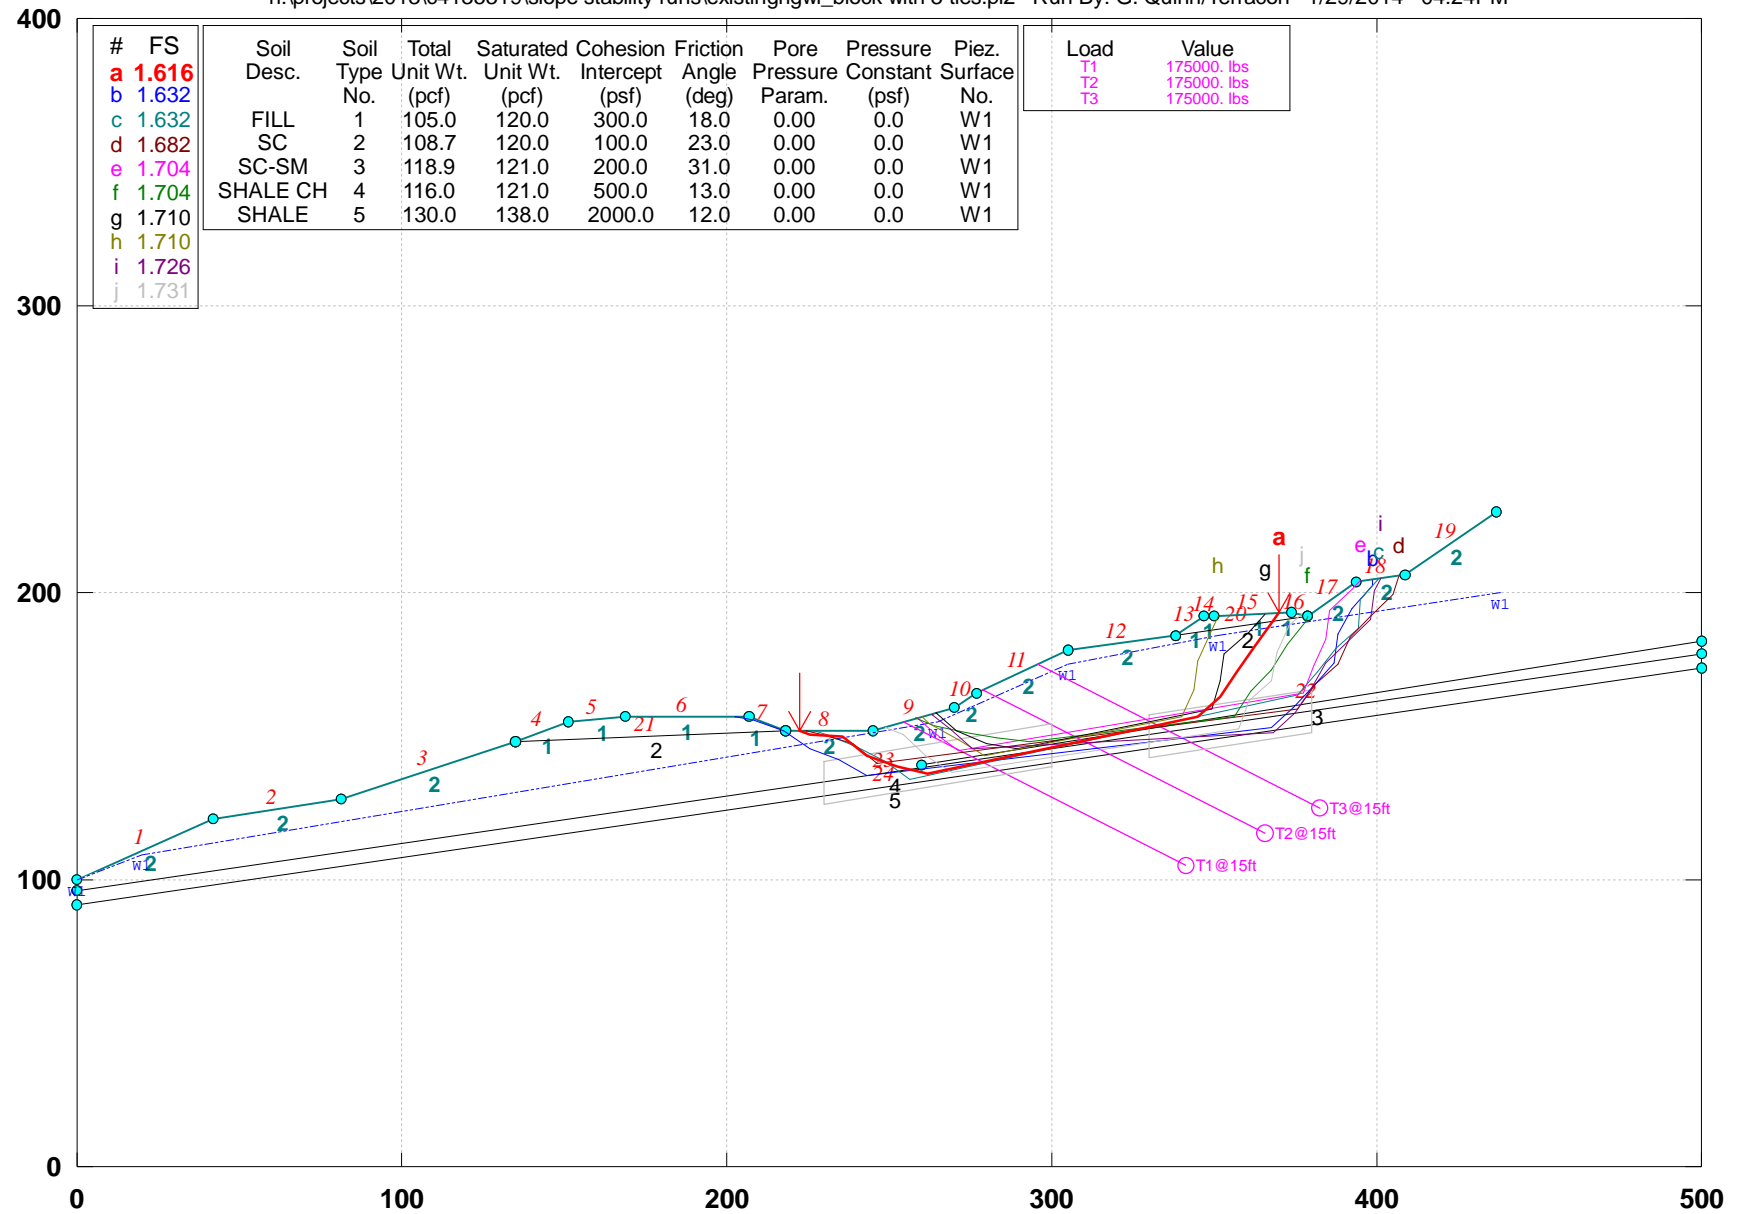
Makoshika Sta 12+00-15+00 Slide Repair/ Block EXHIBIT D-8

GSTABL7 v.2 FSmin=1.616
